Manhole Inspection Summary

Manhole # S33EE1010MH

Insp Date: **4/28/07 10:15 AM**

Location Address: **2 HADLEY SQ**

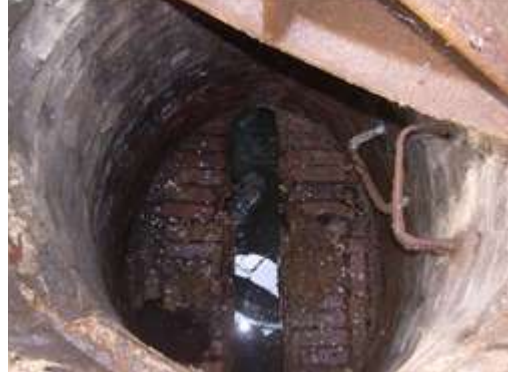
Top View

Corroded steps. Evidence of surcharge - Bench debris. Channel debris.

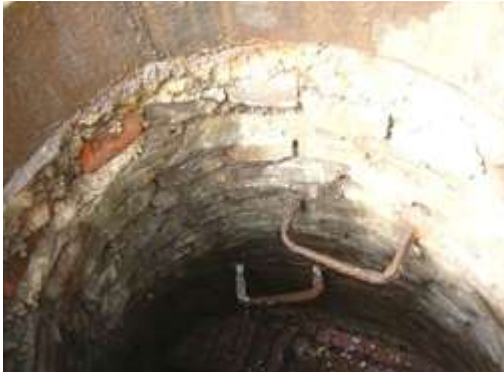
Defect

Frame Offset: **0** (in.) Condition: ☐ Sound ☐ Cracked ☒ **Leaks**

Condition: ☐ Sound ☐ Cracked ☐ Root Intrusion ☐ Loose Brick ☒ **Deteriorated**

Infiltration: ☐ None ☒ **Joint** ☐ Cracks ☒ **Mortar** ☐ Roots ☐ Wall

Infiltration: ☐ None ☐ Joint ☐ Cracks ☒ **Mortar** ☐ Roots ☐ Wall

Frame leaks. Adjustment and Corbel deterioration and infiltration. Barrel infiltration.

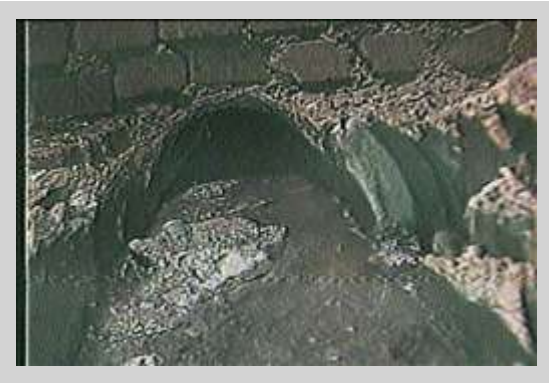
8 in. Circular Gravity Sewer Pipe Out @ 12 O'Clock

Condition: ☐ Sound ☐ Cracked ☐ Root Intrusion ☐ Loose Brick ☒ **Deteriorated**

Infiltration: ☐ None ☐ Joint ☐ Cracks ☒ **Mortar** ☐ Roots ☒ **Wall**

Barrel deterioration and infiltration.

Deposits: ☐ None ☒ **Mud** ☐ Sludge ☒ **Debris** ☐ Grease

Silt Depth: **2** (in.) Deposits Extent: **Medium**

Infiltration: **Evidence** Pipe Seal Cond: **Unknown**

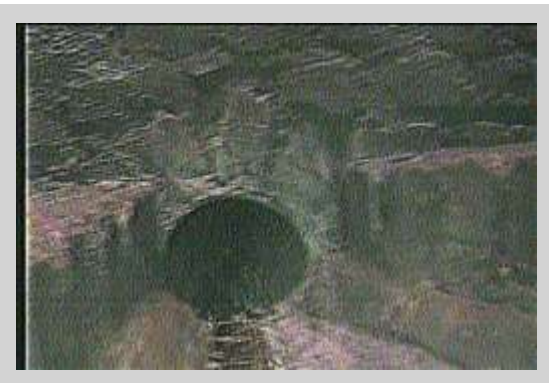
8 in. Circular Gravity Sewer Pipe In @ 6 O'Clock

Condition: ☐ Sound ☐ Cracked ☐ Root Intrusion ☒ **Deteriorated** ☐ Leaks ☐ Debris

Channel deterioration.

Deposits: ☐ None ☒ **Mud** ☐ Sludge ☒ **Debris** ☐ Grease

Infiltration: **None** Pipe Seal Cond: **Cracked**
